WEATHERCRAFT ROOF SURVEY

Acme Recreation Center

123 Green Lane
Husker, Nebraska

RE: Roof Inspection

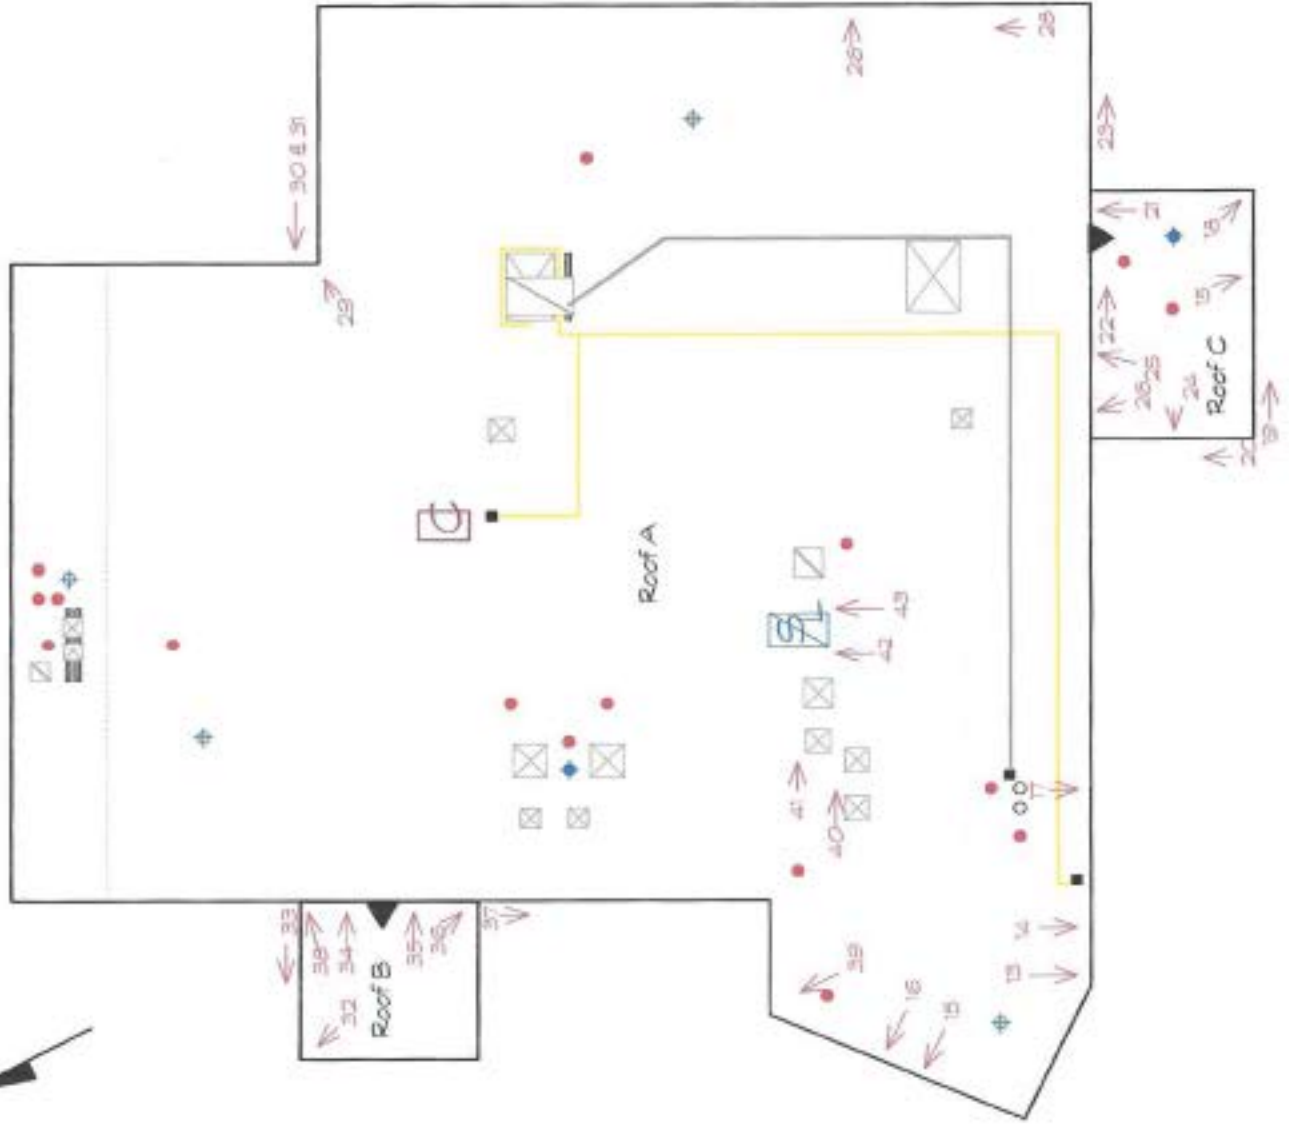
15. MEMBRANE PULLED FROM UNDER METAL
14. MEMBRANE PULLED FROM UNDER METAL
13. MEMBRANE PULLED FROM UNDER METAL
12. MEMBRANE PULLED FROM UNDER METAL
11. MEMBRANE LOOSE FROM METAL
10. MEMBRANE LOOSE FROM METAL
9. METAL BEING PULLED
8. METAL BEING PULLED
7. SIDING LOOSE
6. SIDING LOOSE
5. METAL DISTORTED
4. MEMBRANE LOOSE FROM METAL
3. MEMBRANE LOOSE FROM METAL
2. MEMBRANE LOOSE FROM METAL
1. METAL DISTORTED
28. METAL DISTORTED
29. CORNER PULLED APART
30. CORNER PULLED APART
31. CORNER PULLED APART
32. WIND SCOUR
33. METAL DISTORTED
34. GAP BETWEEN SIDING AND COVER METAL
35. GAP BETWEEN SIDING AND COVER METAL
36. CORNER LOOSE
37. METAL DISTORTED
38. VOID IN LAP
39. WIND SCOUR
40. BRIDGING
41. BRIDGING
42. BRIDGING
43. BRIDGING
